An Investigation into the Radiation Damage of the Silicon Detectors of the H1-PLUG Calorimeter within the HERA environment

Abstract

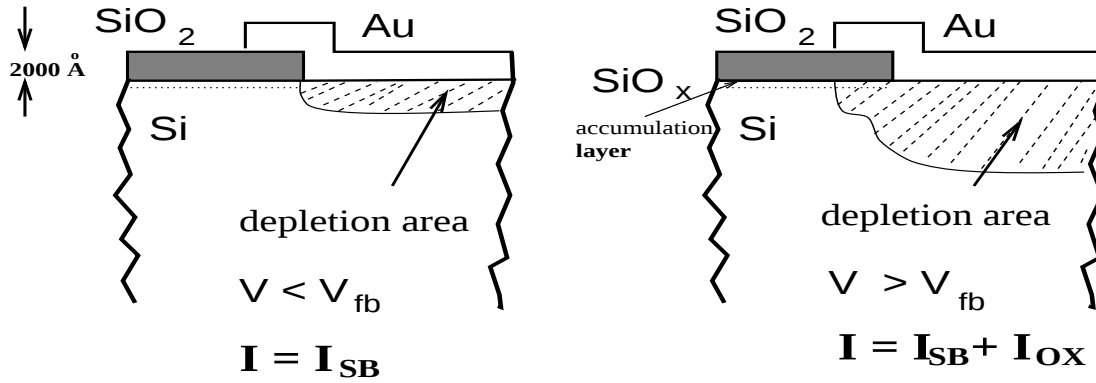
Figure 2: Schematic cross section of one detector, the border of the depleted region is indicated for different voltages.

An unambiguous and simple explanation for the observed break-down effect is difficult. One possible reason is the fact that the positive charge built up in the oxide layer especially below the field plate region at the border of the detector causes a strong increase of the electric field strength (fig. 2). Simulations of the field distribution have demonstrated that the field strength can exceed values high enough for a possible avalanche break-down [13], [14]. Inhomogeneities of the trapped oxide charge distribution may stimulate local avalanche break-down which is commonly called "micro plasma effect". This local effect is normally quenched by the corresponding voltage drop at the bias resistor resulting in large fluctuations of the detector leakage current as can be seen in fig. 6. Such instabilities give rise to an excessive large noise. For more detailed understanding of all damage effects described above further studies and irradiation experiments are in progress.

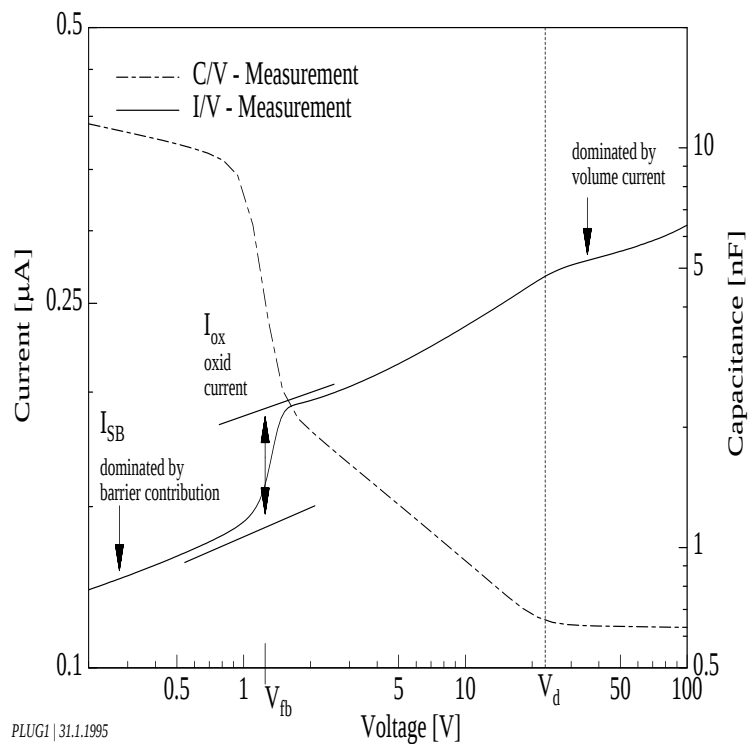
In the figures 2 and 3 the features discussed above are shown for a typical PLUG detector after all technological process steps have been completed but prior to being used during actual beam runs. Figure 2 visualizes the principal electric field extension at the detector edge below and above flat band voltage, the C-V and I-V characteristics are shown in fig. 3. In the given example the flat band voltage turns out to be 1.5 V. This is both seen in the dramatic decrease of the detector capacitance and the jump of the reverse current at that point. For larger voltages the capacitance turns out to be inversely proportional to $\sqrt{V}$ as to be expected by eq. (4) and reaches its geometrical limit of 630 pF at the depletion voltage ($V_d = 22V$), while the current saturates at the same point.

Figure 3: The I/V and C-V characteristics are given for a typical PLUG detector

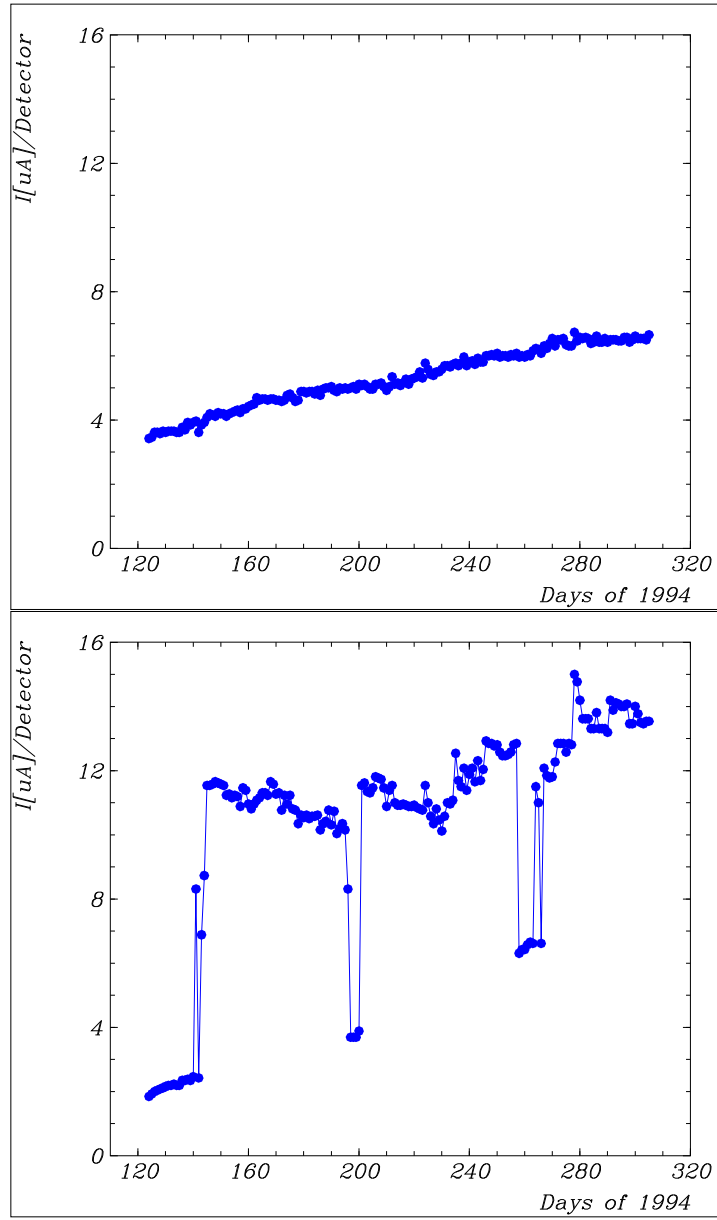
In figure 6 the reverse current as a function of time given in days is plotted for two typical bias-voltage-channels. The first channel shows a continuous development of the reverse current with an almost linear tendency. The increase of the reverse current is due to an increase of the surface contribution as investigated e.g. in ref. [8]. Synchrotron radiation creates new generation centers of charges inside the interface (Si-SiO_2) causing a higher surface current (see fig. 2). This increase is proportional to the absorbed dose. Therefore a radial dependence of the increase is observed with inner detectors showing the strongest effect. Details are discussed in sect. 7. The data were taken on day 242 of the run period (compare fig. 6).

The second channel shows a faster linear increase of the reverse current and its evolution is distorted by strong jumps of the current. These jumps are abnormal, they can be explained by a local break-down of the depletion towards the border of a detector causing a short circuit in the corresponding bias-voltage-ring. The jumps provide high noise spoiling the measurement. Therefore detectors showing break-down have to be removed from the readout ⁴.

Figure 6: Reverse current on a long time scale given for a normal "good" bias-voltage-channel (left side) and one containing at least one "bad" detector (right side), see text.

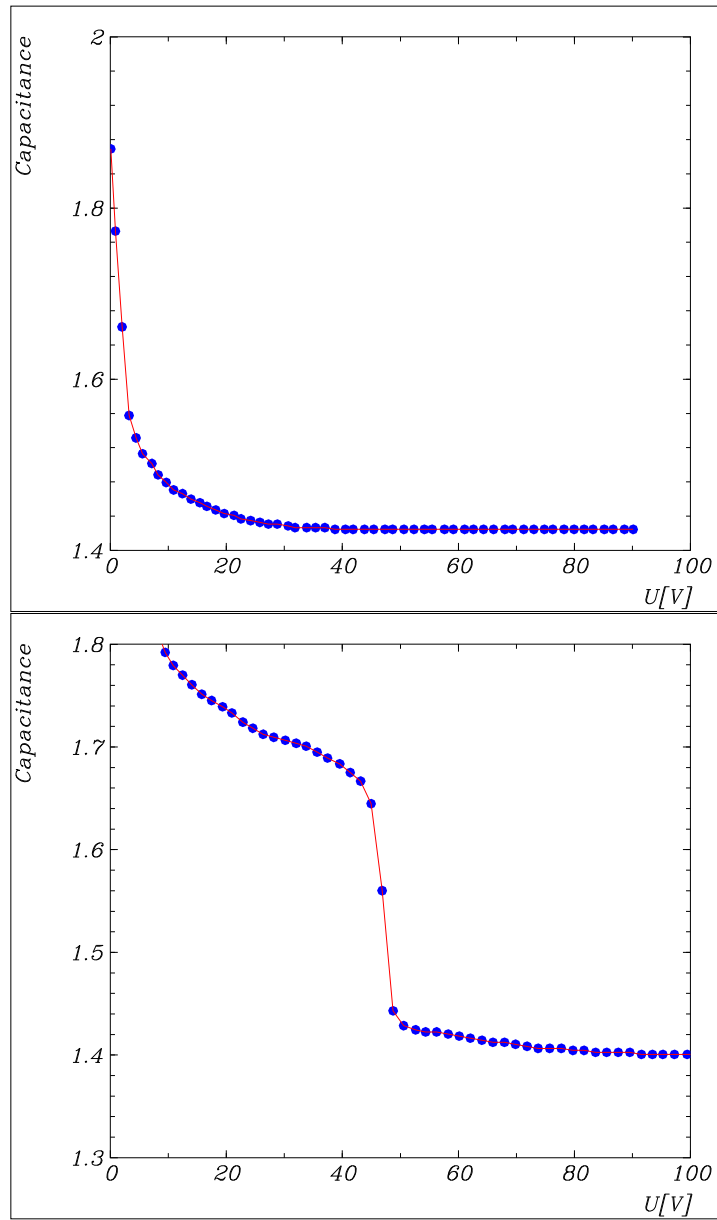
The right part of the figures 8 and 9 represent a different detector with an increased flatband voltage of 45 ± 2 V. This increase is due to radiation damage of the SiO_2 passivation at the border of the detector. The observed flatband voltage is lower than the depletion voltage of 82 V, still visible in the C-V characteristic.

Figure 9: The normal C-V characteristic and the C-V characteristic for a detector with an increased flat band voltage are given as a function of the voltage V .

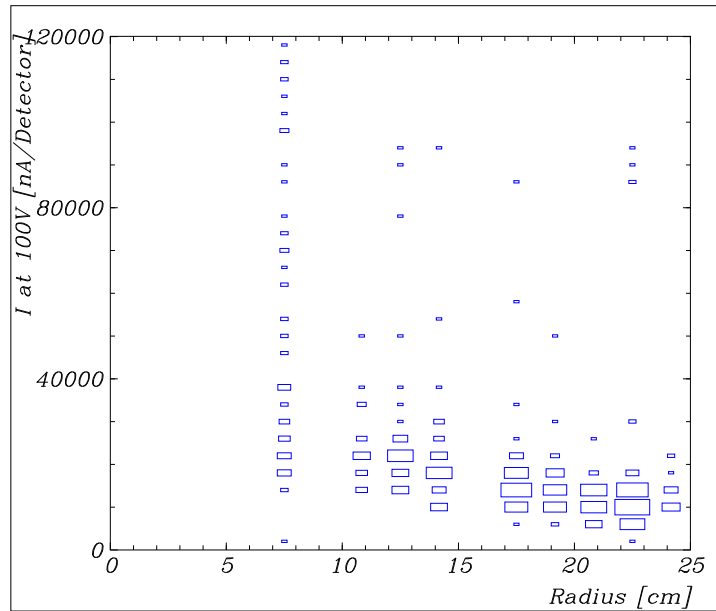
In figure 12 the correlation of the reverse current measured at 100 V and the radial position is shown for the remaining 92 % of detectors. A clear radial dependence of the increase of the reverse current is observed. The closer a detector is mounted to the beampipe the higher is its current. 14 % of the detectors have a current higher than $6 \mu A$. Most of these detectors are situated in the innermost ring. In addition to the radial dependence it should be mentioned that detectors in the most backward plane where the electron beam hits first are damaged more than detectors of the front plane, through which the incoming proton beam passes first. This indicates once more that the increase of the reverse current is caused by electromagnetic radiation.

Figure 12: The detector reverse current at 100 V is correlated with the radial position of the detector.

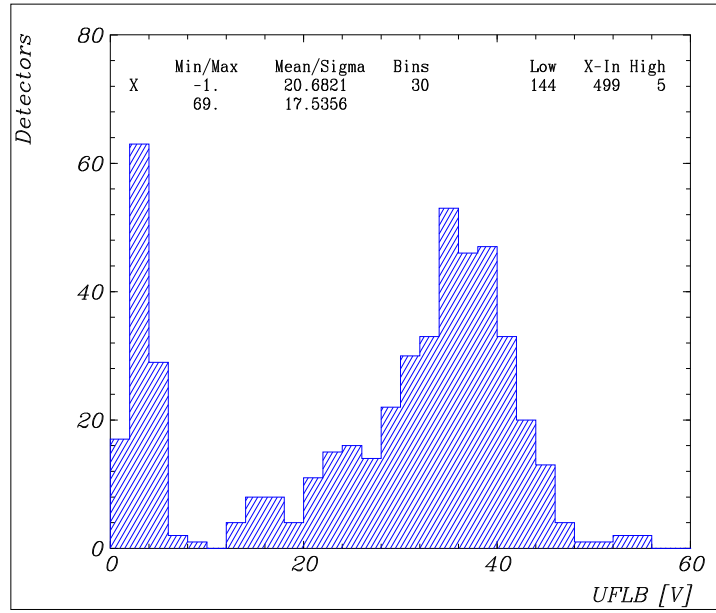
Figure 13 shows the distribution of the measured flat band voltages. Two classes of detectors are visible. The first class has an unchanged flat band voltage of about 2 V. The second class is characterized by an increased flat band voltage of around 35 V.

Figure 13: The distribution of the flat band voltages at the end of the '94 run period is presented.

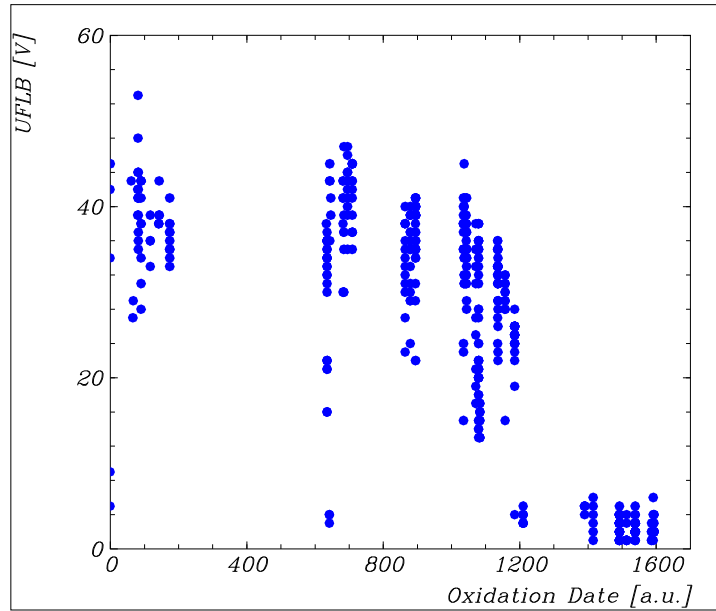
Figure 14 illustrates the correlation of the flat band voltage with the oxidation date of the detector. The correlation with the oxidation date shown over the time period 1990-1993, during which the detectors were produced in different oxidation batches, proves that the newly fabricated detectors show no increase of the flat band voltage while the older ones are characterized by a saturating value of around 35 V. I

Figure 14: The correlation of the flat band voltages with the oxidation date is given. Newly fabricated detectors show no increase of the flat band voltage.
